REPORT OF APOLLO 13 REVIEW BOARD

**APPENDIX B - REPORT OF MISSION
EVENTS PANEL**

**APPENDIX C - REPORT OF MANUFACTURING
AND TEST PANEL**

APPENDIX D - REPORT OF DESIGN PANEL

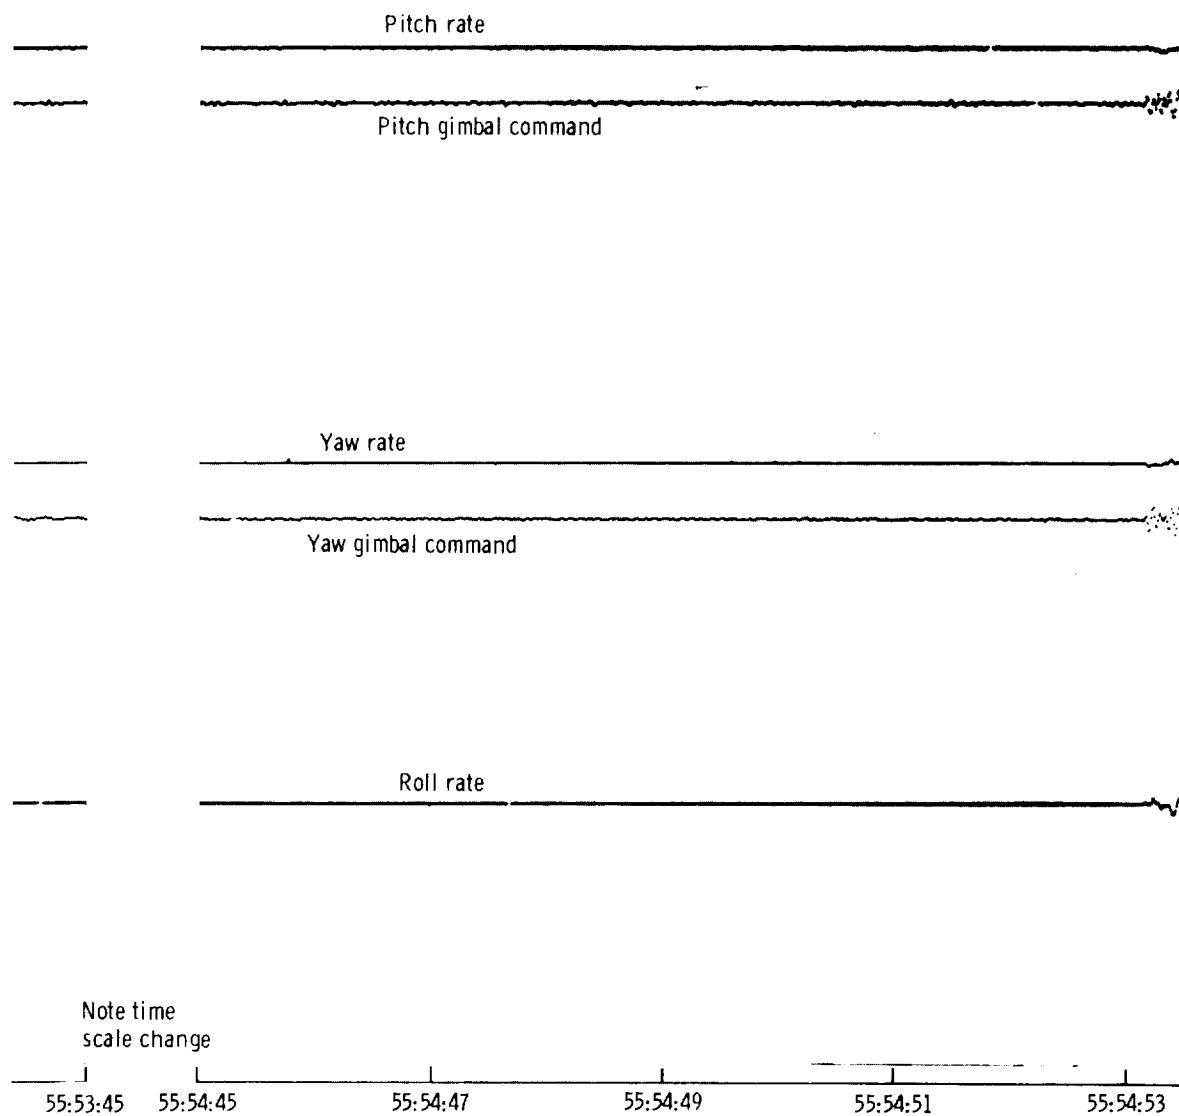
Figure B5-5.- Disturbances observed on thrust vector control gimbal command signals.

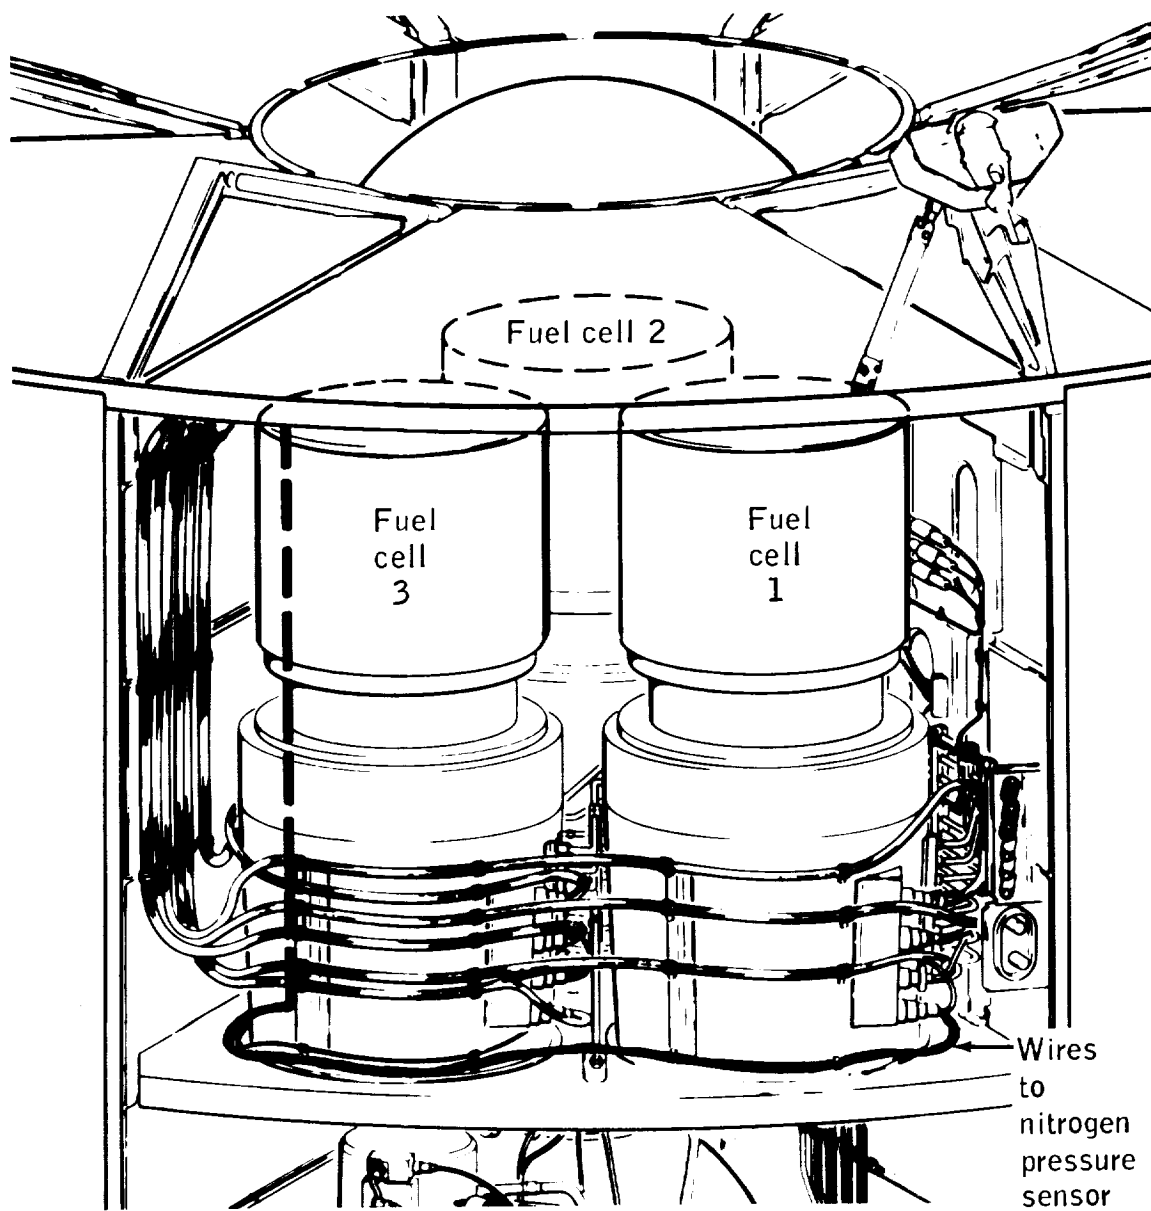
Figure B5-7.- Location of wiring to nitrogen pressure sensor in fuel cell 1.

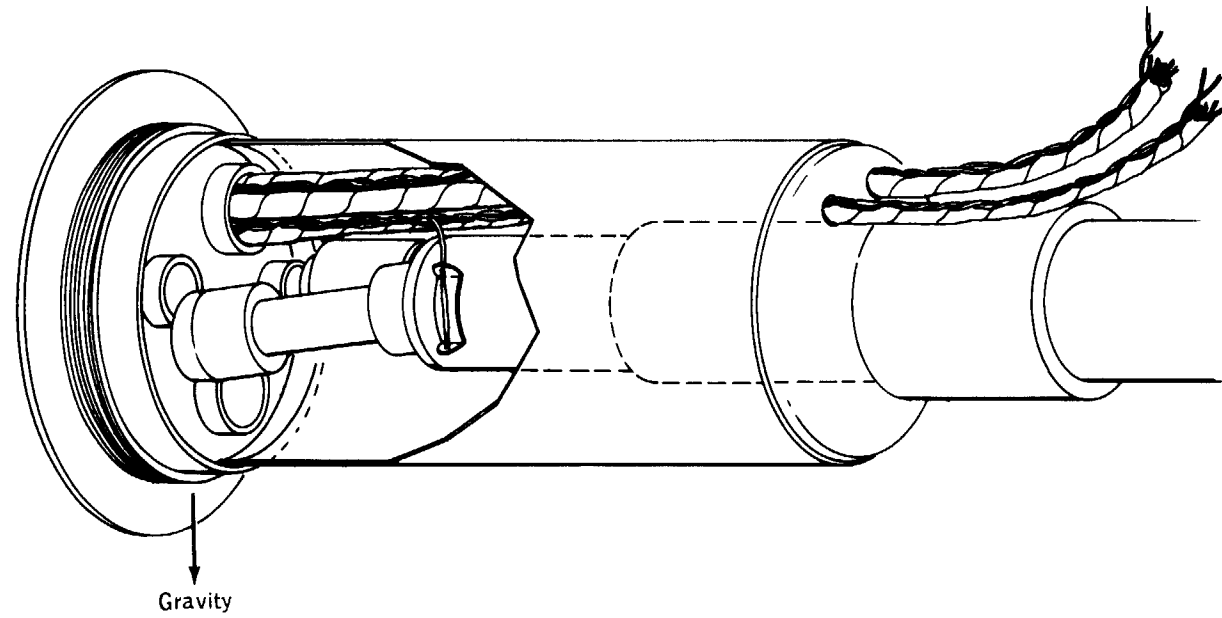
It appears pertinent to this review to note that during SM transportation the fill tube segments within the upper portion of the oxygen tank no. 2 quantity probe assembly lay with the tank-exit end of the fill tube segments about 20 degrees above the horizontal, if they were still in place after previous handling and the "shelf drop." Neither the wires nor the feed line filter were below it to restrict rotation of the fill tube about the central tube of the quantity probe (fig. C4-64).

Figure C4-64.- Isometric sketch of quantity probe head as oriented during SM transportation.

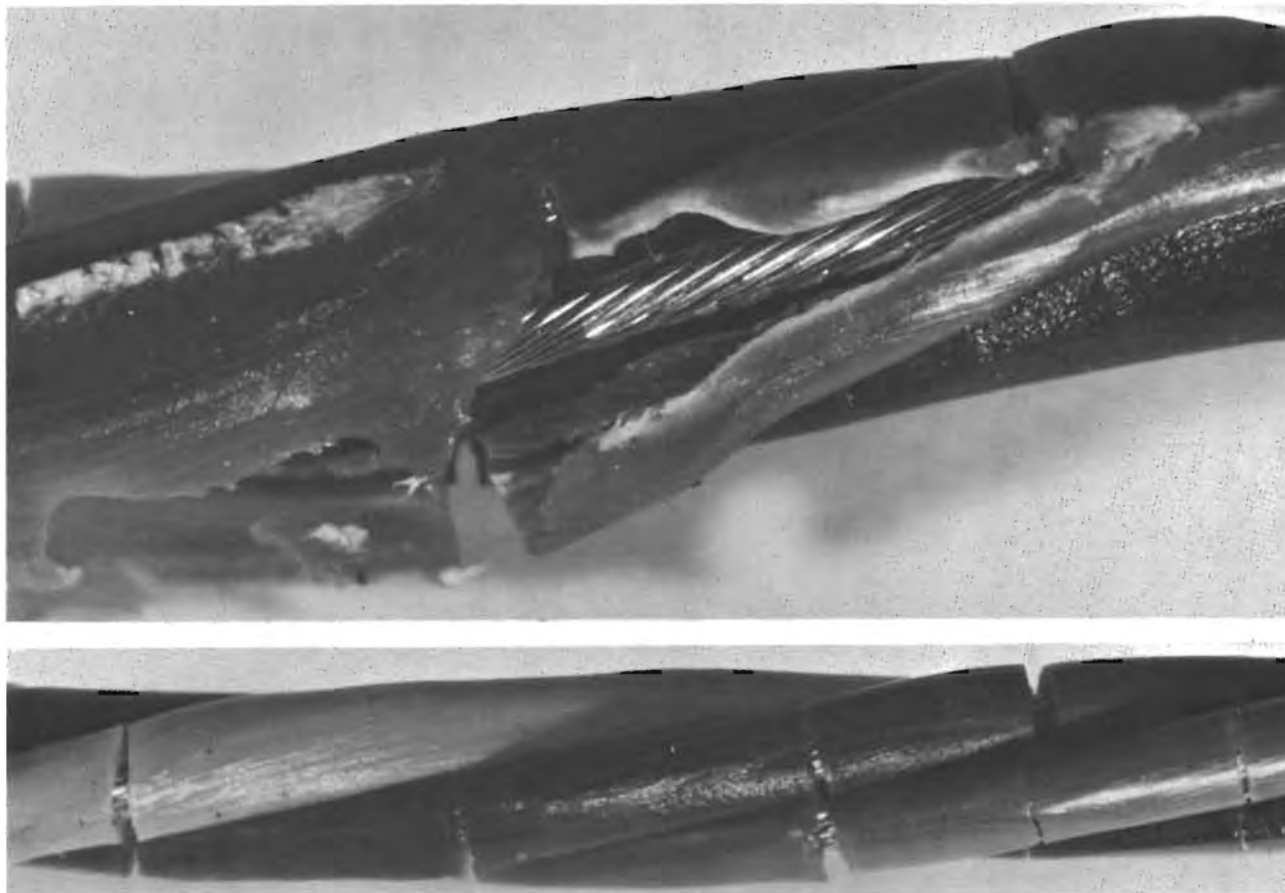
Figure C4-68.- Wire damage from heater tube assembly temperature test.

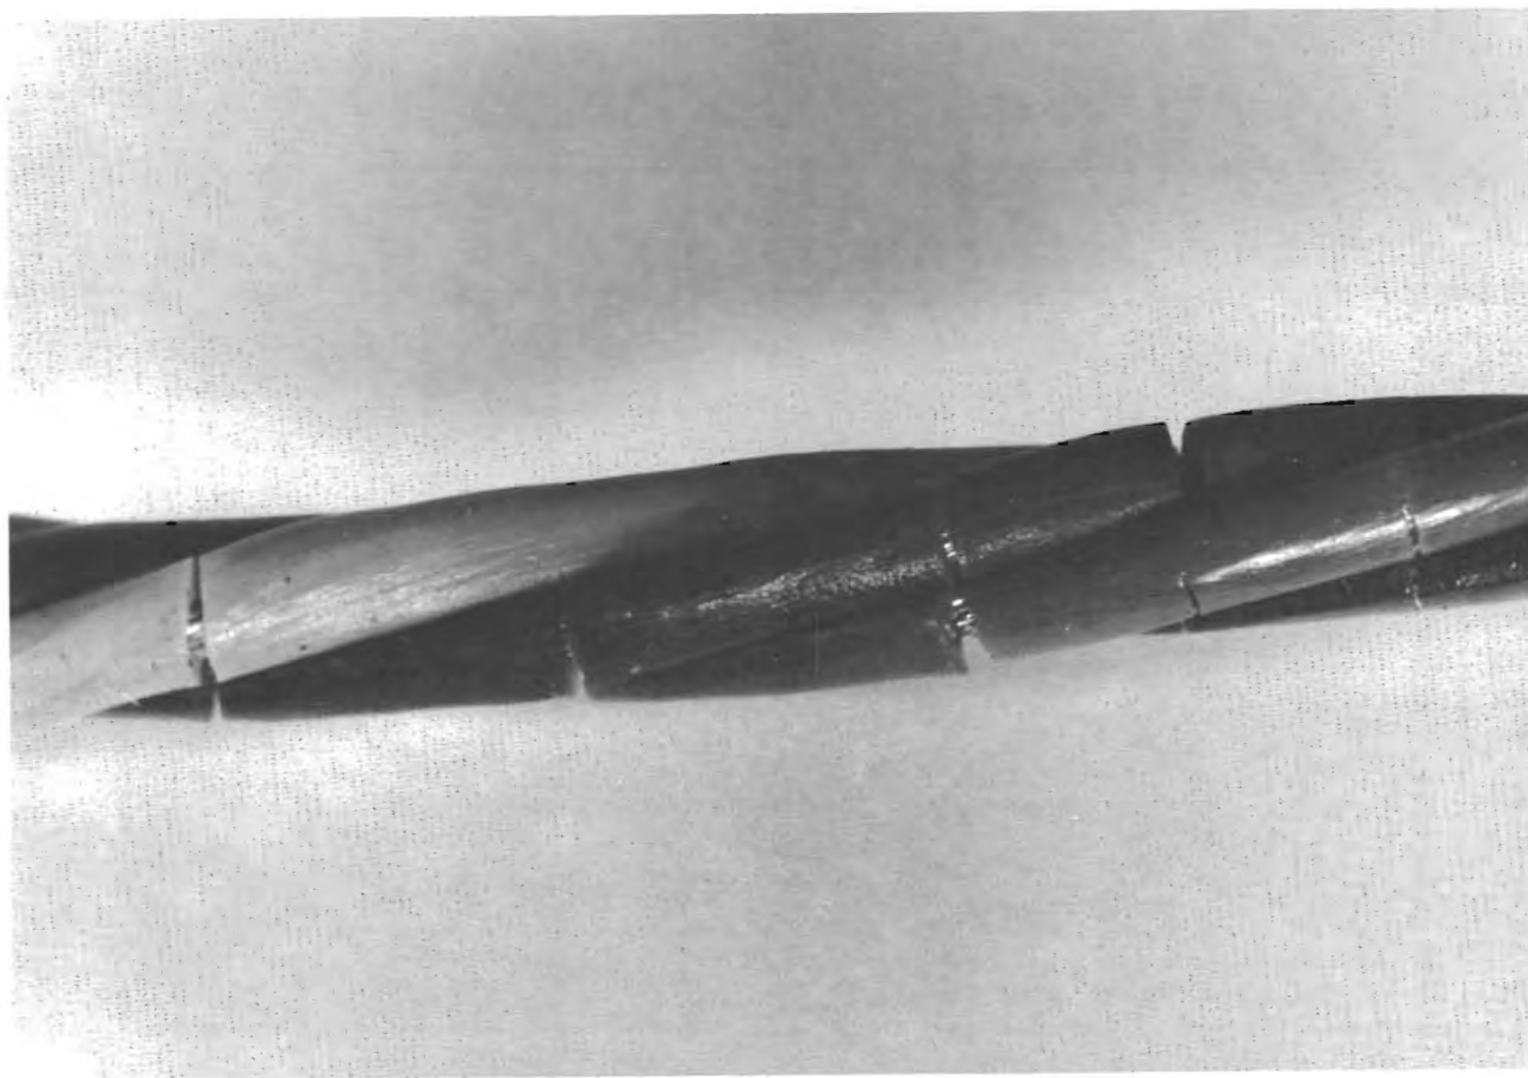
Figure D3-24.- Photograph of wire damage.
